Piping Failure Remediation of Barrage Structure: from Analysis to Construction

Soebagio [1], Danang Setiya Raharja [2],*, and Siswoyo [3]

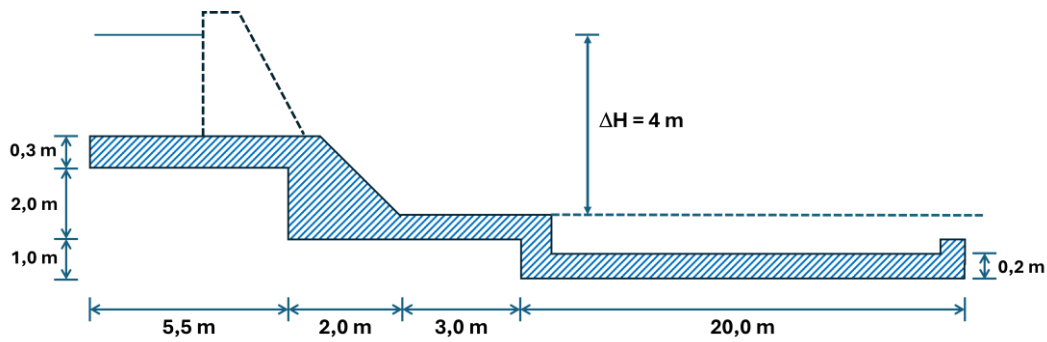
Figure 6.   Initial dimension of barrage structure

The sketch of initial condition and dimension of existing barrage structure is shown in **Fig. 6**. The back calculation by Lane's theory was conducted by follow the equation 1. The details calculations are as follows:

The soil under barrage identified as sand with medium size, so the C_1 value is taken as interpolation between fine sand ($C_1 = 7$) and coarse sand ($C_1 = 5$), which is equal to $C_1 = 6$. The head causing water flow is 4 m as shown in **Fig. 6**.

Because the value of $C_1 H_L$ still greather than the value of L_1, so that there will be a piping and in further will lead to the collapse of the Tinggar Barrage.

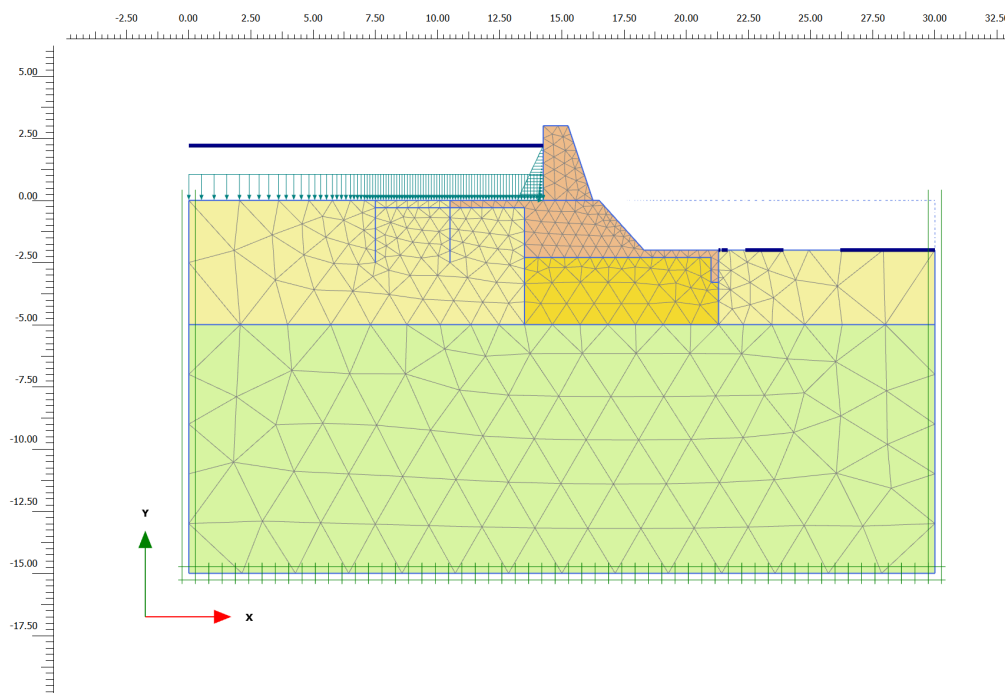
Figure 7.   Model geometri of existing barrage for back analysis using Plaxis

While the back analysis with numerical method by using Plaxis software was performed with detailed geometry as shown in **Fig. 7**. The first layer (yellow color) is sand soil, and the second layer (green color) is silty sand soil, while for the soil under barrage structure (orange color) is sand gain soil which is stronger sand soil due to the consolidation process along the period since the barrage was built. The detailed soil parameter input is presented in **Table 1**. The barrage structure (brown color) is modelled as linier elastic material with non-porous drainage type, γ 20 kN/m³, E 200000 kN/m², and v 0.2. The water level (head in the upstream side) is modelling with phreatic line as shown in the **Fig. 6** so that the difference with the water level in the downstream side is equal to 4 m.

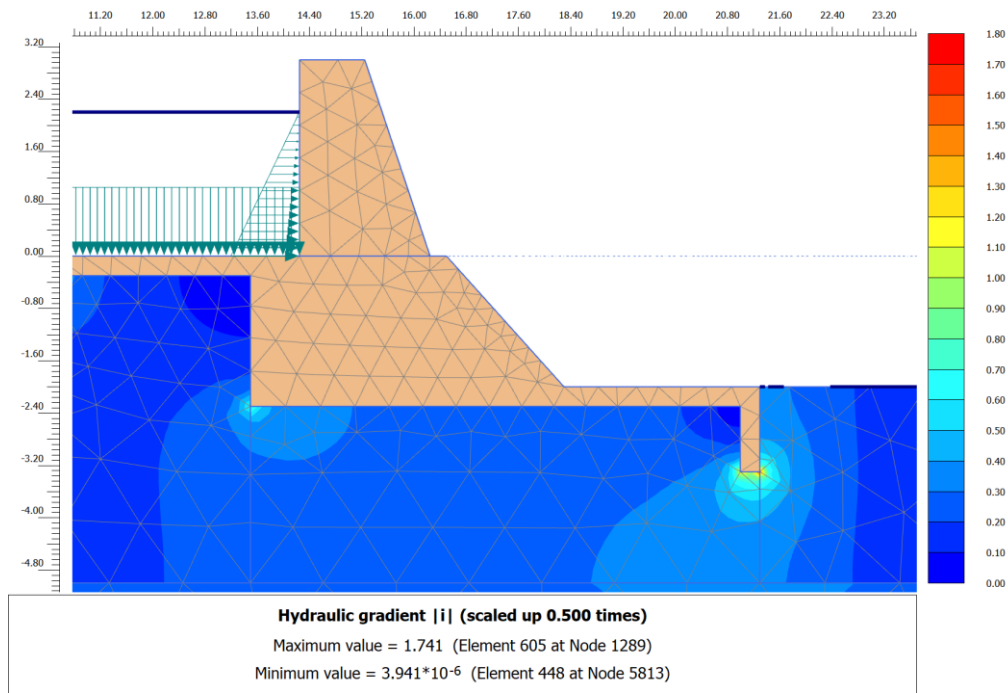
Figure 8.   Plaxis output – hydraulic gradient of the existing barrage

The groundwater flow is performed by using steady state analysis. The visualization of hydraulic gradient shown in **Fig. 7** including color scale which shows the magnitude of the hydraulic gradient value along the soil cluster. From the color scale, it can be identified that the maximum hydraulic gradient at downstream side (exit gradient) is between 0.30 to 0.40. The value of critical gradient is calculated by following equation 8 and the parameter of G_s and e can be extracted from **Fig. 4**. After that, the factor of safety against piping can be calculated, and the result is 1.875 which is less than minimum criteria (SF_{min} = 4), so that it is confirmed that the piping failure of the barrage was caused by the structure not sufficient.

$$i_c = \frac{Gs-1}{1+e} = \frac{2.58-1}{1+1.10} = 0.75$$

$$SF_{piping} = \frac{i_c}{i_e} = \frac{0.75}{0.40} = 1.875$$

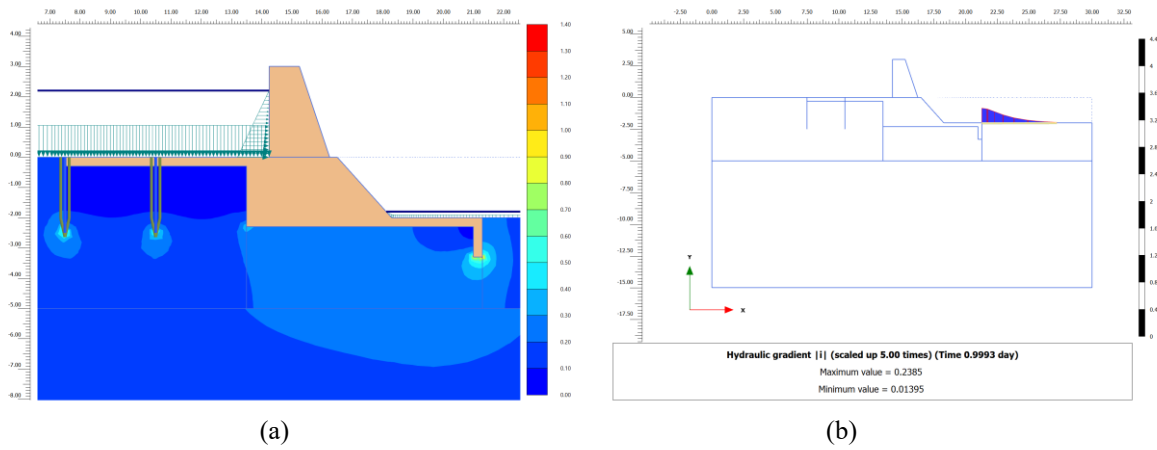
Figure 10. Plaxis result of proposed design (a) shading visualization of hydraulic gradient and (b) cross section of hydraulic gradient in the downstream

Meanwhile, the Plaxis model is also updated by adding 2 lines of vertical wall which is modelled by using plate element. The shading visualization of hydraulic gradient (Fig. 10a) shows that the value slightly decreases to around 0.20 to 0.30 compared to the existing hydraulic gradient was 0.40 (which is 0.1 to 0.2 smaller). The cross section of hydraulic gradient in the downstream area was made to get precise value (Fig. 10b) which is 0.238. Therefore, the factor of safety increases to 3.15. Even though this SF value still less than minimum criteria ($SF_{min} = 4$), but the value is quiet high and can be consider as the safe value against potential of piping failure.

$$SF_{piping} = \frac{i_c}{i_e} = \frac{0.75}{0.238} = 3.15$$
